Sloan Flushometer

Manual
Flushometers

PARTS LIST

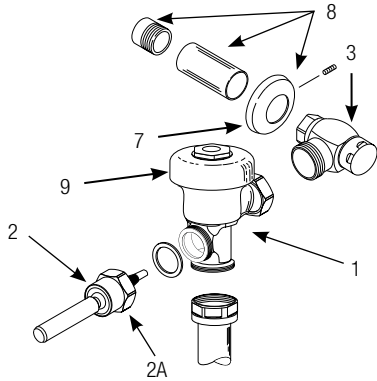
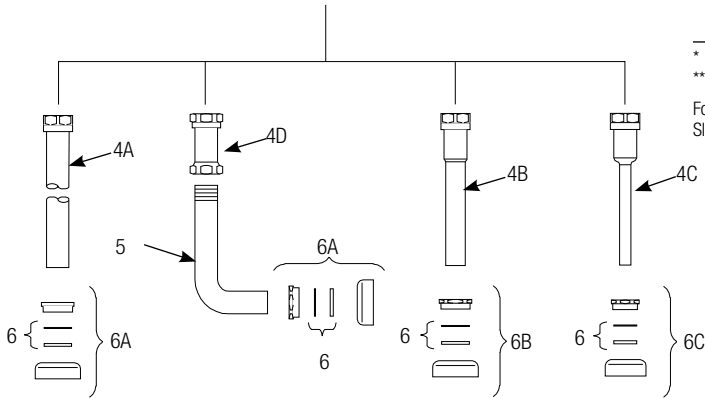
Item No.	Code No.	Part No.	Description
1.	—	A-3-A	Valve Assembly – contact Tech Support for proper assembly
2.	0302390	B-73-A	ADA Compliant Handle Assembly
2A.	0301082	A-6	CP Handle Coupling

3.	—	H-710-A	Bak-Chek® Control Stop – 3/4" or 1"
4A.	5323007	V-500-AA	1-1/2" (38 mm) x 9" (229 mm) Vacuum Breaker Assembly ** – 6 per package
4B.	5323006	V-500-AA	1-1/4" (32 mm) x 9" (229 mm) Vacuum Breaker Assembly – 6 per package
4C.	5323005	V-500-AA	3/4" (19 mm) x 9" (229 mm) Vacuum Breaker Assembly – 6 per package
4D.	—	V-500-A	Vacuum Breaker Assembly

5.	0396293	F-109	1-1/2" (38 mm) Elbow Flush Connection
6.	SEE SLIP JOINT GASKETS AND RINGS TABLE BELOW		
6A.	0306145	F-56-A	1-1/2" (38 mm) Spud Coupling Assembly
6B.	0306142	F-55-A	1-1/4" (32 mm) Spud Coupling Assembly
6C.	0306102	F-54-A	3/4" (19 mm) Spud Coupling Assembly

7.	—	F-7	Supply Flange (Supplied when Valve is not Ordered with Sweat Solder Kit)
8.	3308782	H-633-AA	1" (25 mm) Sweat Solder Kit with Cast Set Screw Flange
	3308788	H-636-AA	3/4" (19 mm) Sweat Solder Kit with Cast Set Screw Flange

9.	0378000PKSV-10		CP Sloan Cover
	0378003PKSV-10-HE		CP High Efficiency Sloan Cover

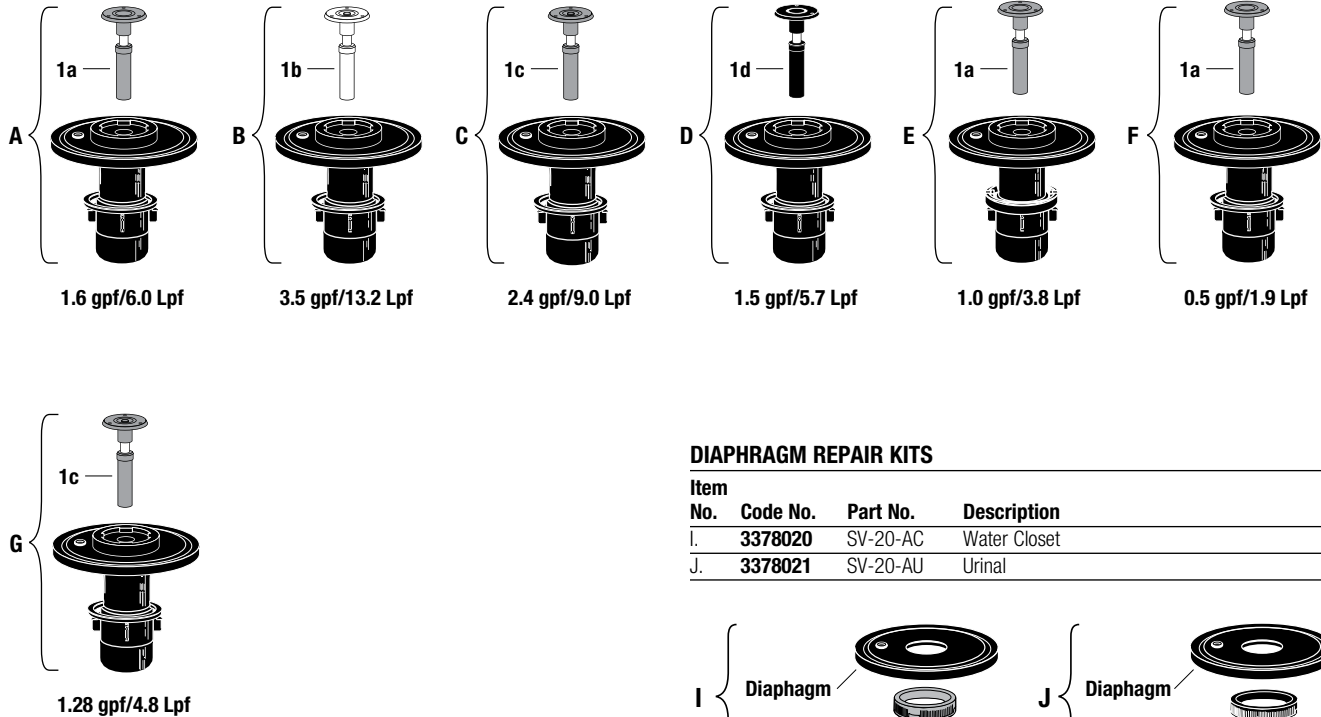
INSIDE COMPONENTS

Item No.	Code No.	Part No.	Description
1a.	5301211	A-19-ALC	Relief Valve, Green (Closet/Urinal-LC) – 12 per package
1b.	5301058	A-19-AC	Relief Valve, White (Closet) – 12 per package
1c.	0301143	A-19-AL	Relief Valve, Blue (9 Liter Closet)
1d.	5301059	A-19-AU	Relief Valve, Black (Urinal) – 12 per package

Item No.	Code No.	Part No.	Description
I.	3378020	SV-20-AC	Water Closet
J.	3378021	SV-20-AU	Urinal
